Tank Inspection Report - xxxxxxxxxx

The slurry tank at the above premises was inspected on 25th October 2016. The tank is labelled as being sold by Alfa Laval, but was in fact manufactured by Boythorpe, who are no longer in business. Probably supplied and erected in the mid 1980's, the design life of this type of tank is twenty years. It is four rings (4.8m) high, 32 sheets round, 80'0"(24.38 m) diameter, gross capacity 2,235m³.

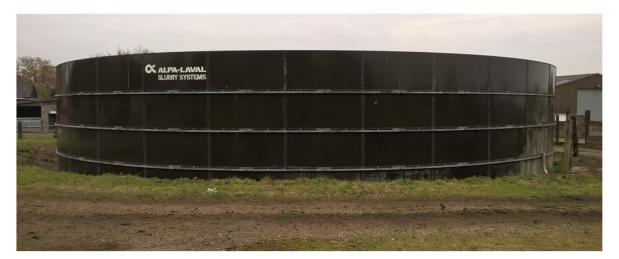
The exterior of the tank is in good order, with a few minor areas of damaged enamel. There is some scrub close to the tank, and I suggest clearing the exterior concrete fillet and making sure any water coming out of the higher ground on the South elevation is not trapped. A drain in this position would contravene EA regulations, and must <u>not</u> be installed. The wind stiffeners are in position and in good order. The top stiffening angle is constructed from single galvanised 60 x 60 angles, with joiners, and is in good condition. The ladder work and platform is agricultural standard and serviceable. A jetter is fitted which could be used for filling, connecting to the existing 5" hose by Bauer type coupling.

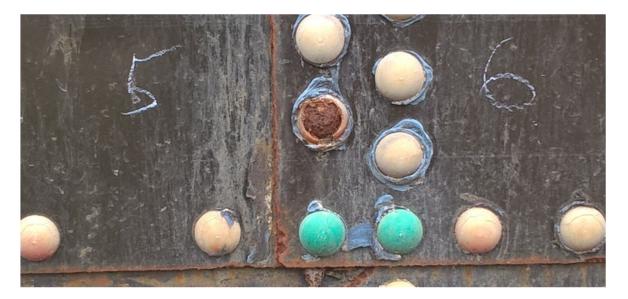
Below is a bolt with the plastic coating damaged. Such bolts must be replaced with new.

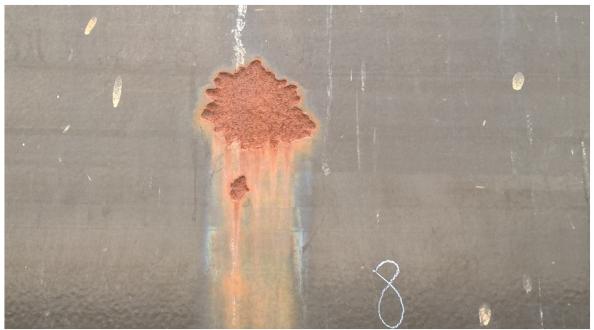
The next picture shows some deep corrosion on the inside surface. This should be treated by cleaning and applying mastic, additionally covering with stainless steel plate, 1.0mm minimum thickness, held in place with stainless self drilling screws.

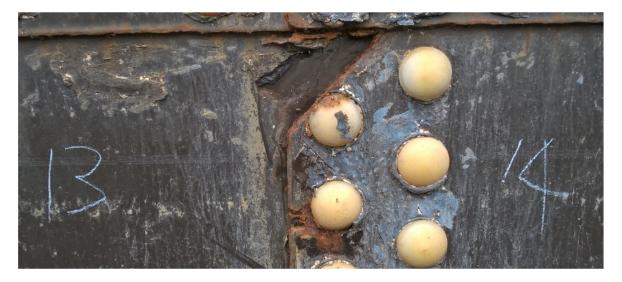
As mentioned above, the bottom two rows of sheets have indents near the top of the vertical seams. These can lead to corrosion travelling from the sheet edge to the bolt holes, with disastrous consequences. Particular attention should be given to these points.

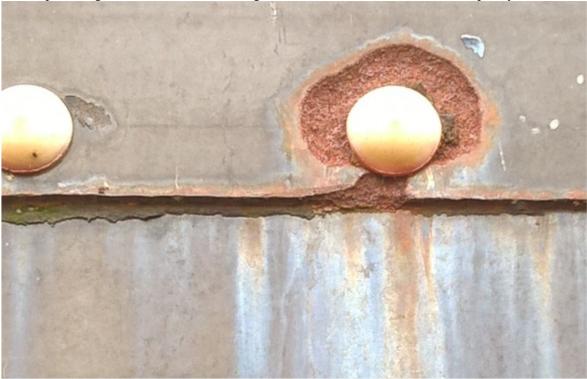
In a few places on the horizontal seam, the bolt head has damaged the enamel, allowing deep corrosion. The bolt should be replaced and the area treated and covered with a stainless steel washer plate of greater area than the damage, and minimum 2.5mm thick, with plenty of mastic.

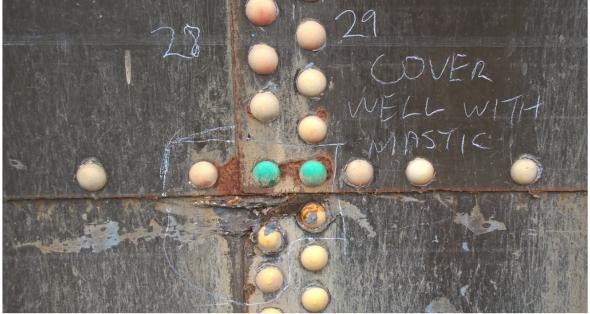
The area shown below should be cleaned and covered completely with mastic, replacing the bolts with new.

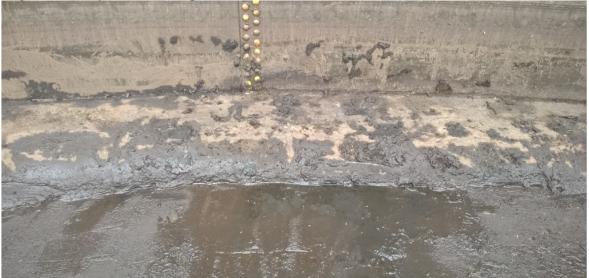
It appears that slurry has seeped behind the fillet and is escaping at this point. There is no evidence of leakage to the outside, so no treatment is required at this stage. We will advise if longer than five years' use is expected.
